Manhole Inspection Summary

Manhole # S29Q1_025MH

Insp Date: **2/22/08 11:00 AM**

Location Address: **2860 Bookert Dr**

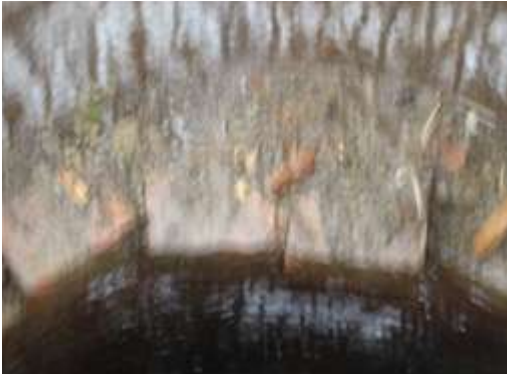
Defect 1

Condition: ☐ Sound ☐ Cracked ☐ Root Intrusion ☒ **Loose Brick** ☐ Deteriorated

loose bricks

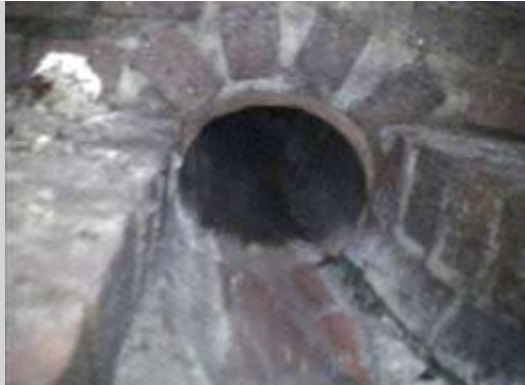
12 O'Clock Outflow

8 in. Circular Gravity Sewer
Pipe Out @ 12 O'Clock

Pipe Height: **10.8** (in.) Rod and Bar (Angled)
Pipe Material: **Clay** ☐ Pipe Lined
Invert Depth: **9.29** (ft.) Flow Characteristics: **Fast**
Deposits: ☒ None ☐ Mud ☐ Sludge ☐ Debris ☐ Grease
Silt Depth: (in.) Deposits Extent:
Infiltration: **None** Pipe Seal Cond: **Sound**

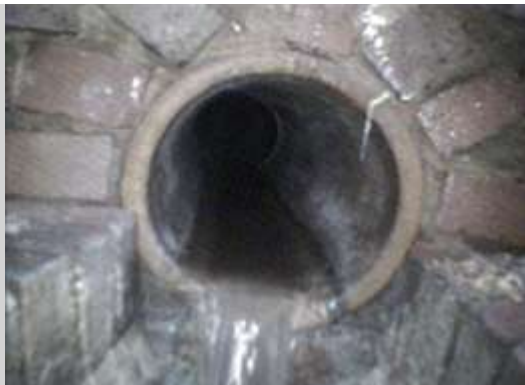
3 O'Clock Inflow

8 in. Circular Gravity Sewer
Pipe In @ 3 O'Clock

Pipe Height: **9.6** (in.) Rod and Bar (Angled)
Pipe Material: **Clay** ☐ Pipe Lined
Invert Depth: **8.66** (ft.) Flow Characteristics: **Fast**
Deposits: ☒ None ☐ Mud ☐ Sludge ☐ Debris ☐ Grease
Silt Depth: (in.) Deposits Extent:
Infiltration: **None** Pipe Seal Cond: **Sound**
